# Evaluation of a Vibration Diagnostic System for the Detection of Spiral Bevel Gear Pitting Failures

Dennis P. Townsend and James J. Zakrajsek  
*Lewis Research Center*  
*Cleveland, Ohio*

Prepared for the  
Seventh International Power Transmission and Gearing Conference  
sponsored by the American Society of Mechanical Engineers  
San Diego, California, October 6-9, 1996

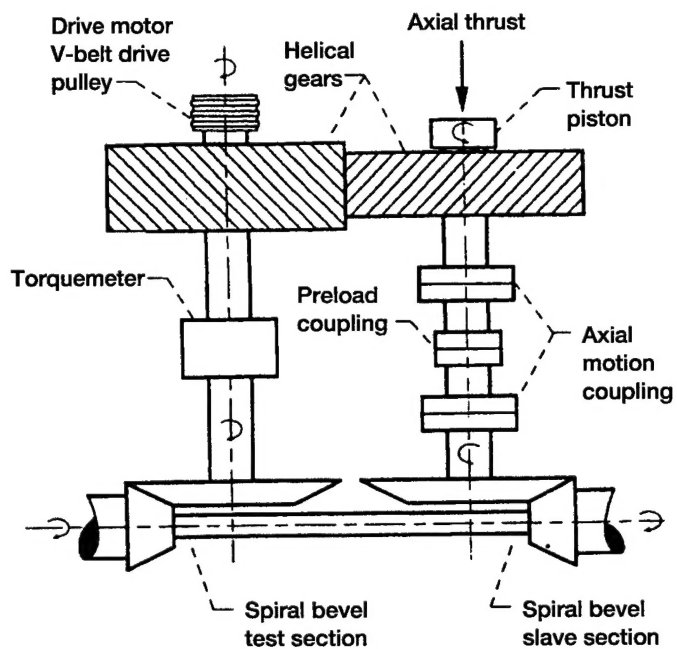
Figure 1.—Crosssection view of test facility.

The spiral bevel gear test rig used for the testing conducted herein is one of two such facilities at NASA Lewis Research Center. A sketch of the bevel gear test rig is shown in Fig. 1 and a cross-section of the test rig showing the main features is shown in Fig. 2. The bevel gear test rig is a closed-loop, torque-regenerative system with a closed loop capacity of 560 kW (750 hp). Power for the rig is provided by a 75 kW (100 hp) variable speed drive motor. The torque is controlled in the closed loop by moving a helical gear with a hydraulically actuated thrust piston. A torque

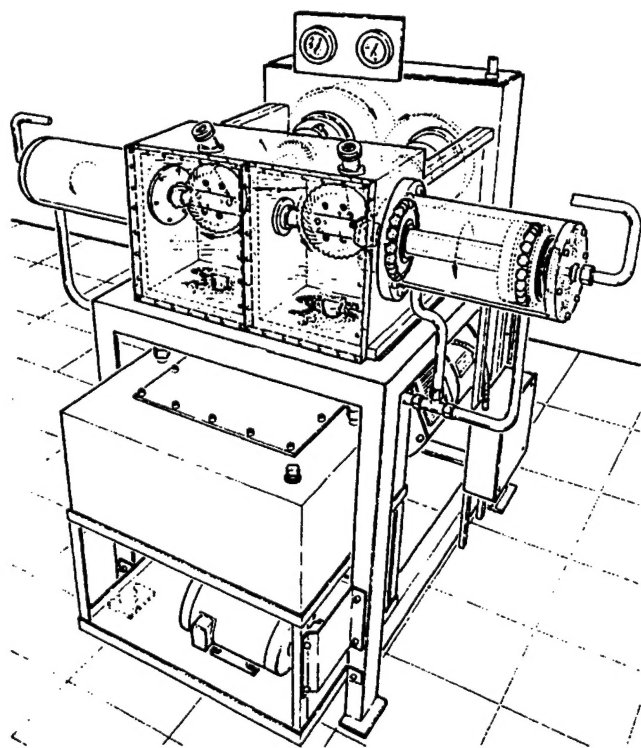
Figure 2.—Sketch of spiral bevel test facility.

As shown in Fig. 2 two sets of spiral bevel gears are tested simultaneously. The slave (right) side operates in a speed increaser mode, where the gear drives the pinion. The test (left) side operates in the intended fashion as a speed reducer. The gear ratio for the test rig is three to one with 12 teeth on the pinion and 36 teeth on the gear. A photograph of the test gears is shown in Fig. 3. The test hardware basic design parameters are given in Table I.

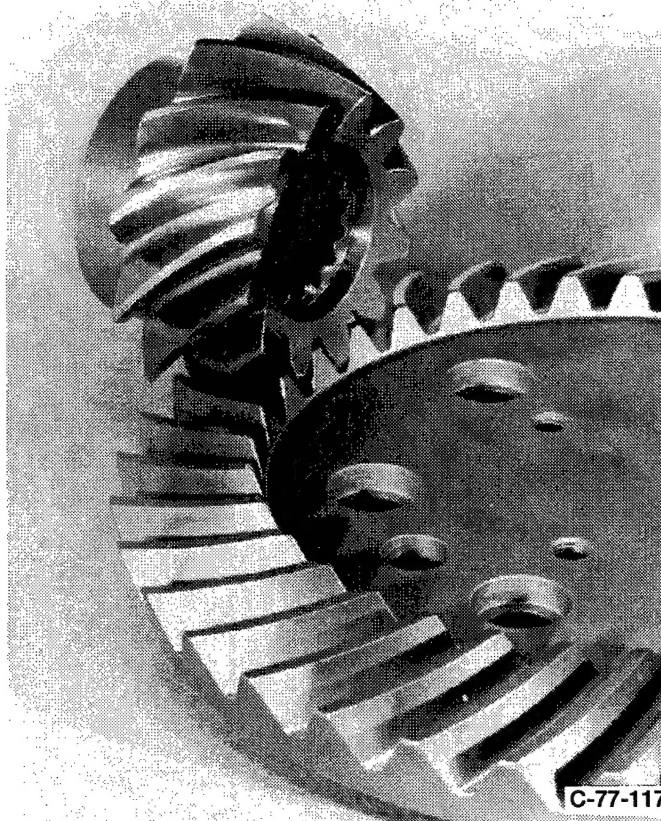
Figure 3.—Spiral bevel test gears.

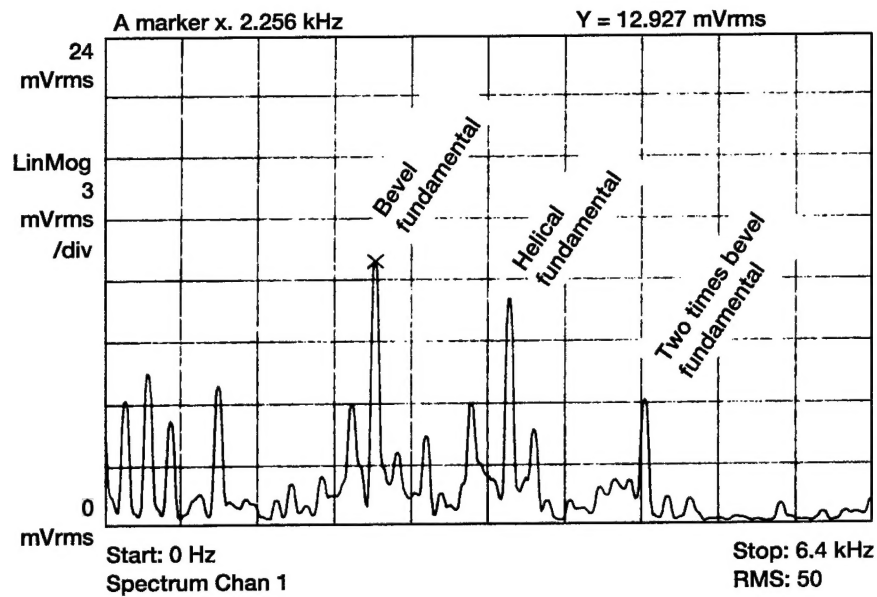
Figure 4.—Typical vibration spectrum from NASA Bevel Gear Rig Pinion speed 11 400 rpm, gear speed 3800 rpm, torque on gear shaft 938 N m (8300 lb/in.).

Accelerometer vibration measurements were taken on the bevel gearbox to find the best vibration accelerometer location, because vibration modes of the gearbox case can affect the gear vibration signal. The best location was found to be on the pinion bearing housing adjacent to the test gear. Figure 4 is a spectrum of the test gearbox showing the various vibration frequencies. The once per revolution of the pinion and the first and second harmonic of gear mesh frequency are clearly seen. The peak at approximately 1.5 times the pinion mesh frequency is the mesh frequency of the helical gears which have 55 teeth each.

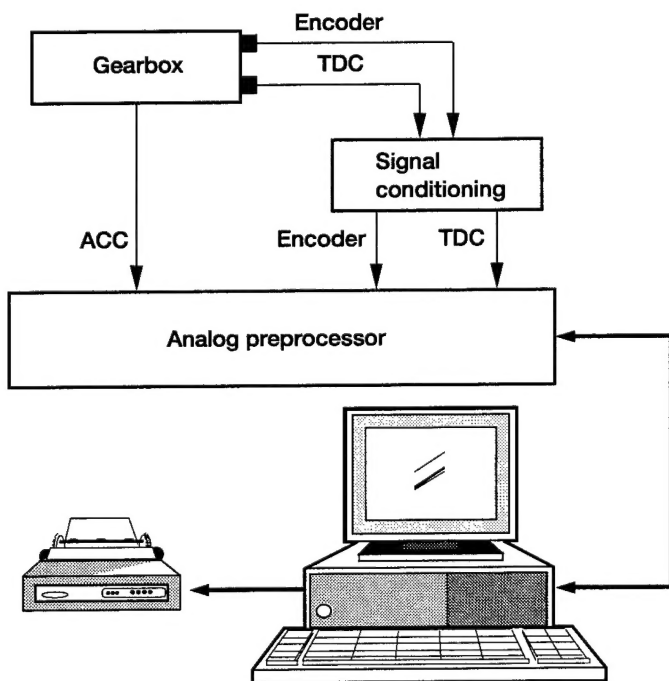
Figure 5.—Gear diagnostic system.

The diagnostic system used in this research program is a commercial gear diagnostic system. The system consists of a personal computer with an analog to digital board installed, a signal conditioning system, and a software package. A schematic of the system is shown in Fig. 5. The signal conditioning system includes a computer controlled tracking filter, computer controlled analog signal conditioning, a pulse rate multiplier/divider, and interfacing electronics. The software automatically sets and monitors the analog signal conditioning circuitry, performs the analysis and provides monitor displays of individual gear tooth vibration images. Gear condition status and alarms are issued when appropriate. The software can display current and past data in a variety of different formats. A flow chart of the system is shown in Fig. 6.

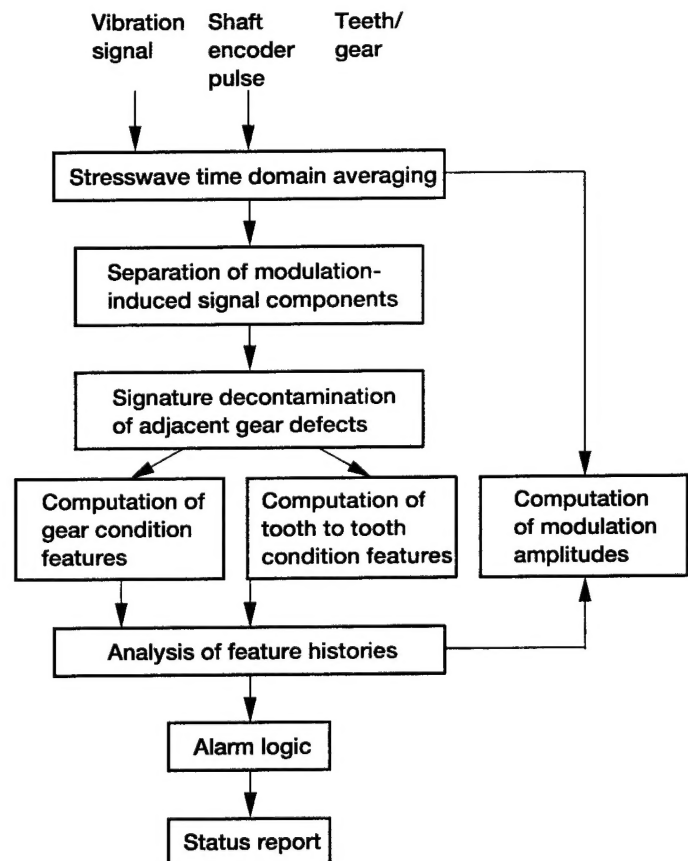
Figure 6.—Gear diagnostic system flow chart.

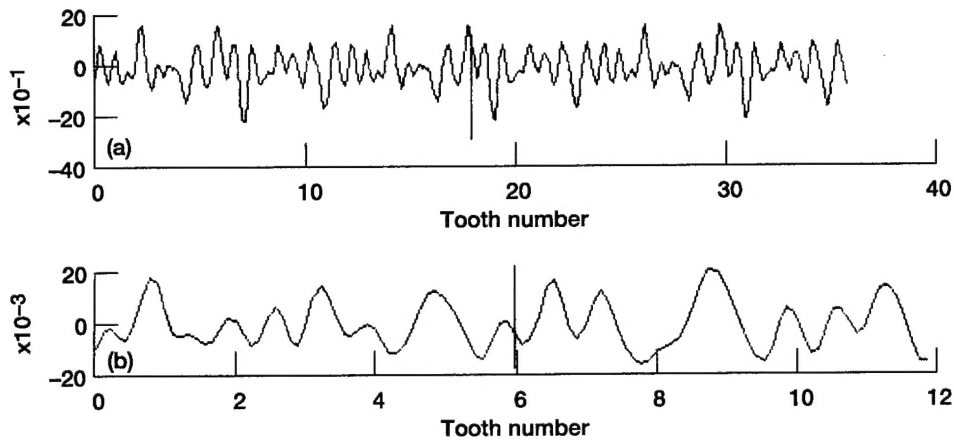
Figure 7.—Typical time synchronous average plots for spiral bevel test rig. Pinion speed 11 400 rpm, gear torque 938 N m (8300 lb/in.). (a) Gear baseband plot. (b) Pinion stresswave.

amplitude modulation function, or envelope, was then constructed. The envelope of the baseband vibration depicts the vibration pattern of each tooth on the gear, using the low frequency components of the signal. Figure 7 shows examples of gear baseband and pinion stresswave plots. The stresswave plots are generated from a high frequency band. This high frequency band was demodulated about a harmonic of the meshing frequency, then the amplitude modulation function was constructed. The envelope of the high frequency band is also known in this system as the gear stresswave. The stresswave depicts the vibration pattern of each tooth on the gear, using the high frequency components of the vibration signal. In many cases the resolution of the tooth meshing pattern is considerably better in the stresswave, than the baseband envelope. This is due to the decreased effect of the vibration transfer path dynamics at higher frequencies.

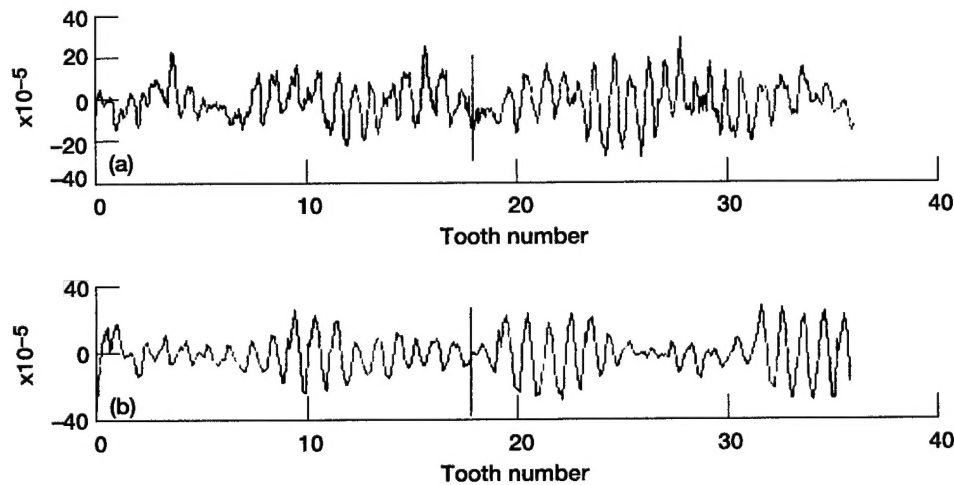
Figure 8.—Time synchronous average plots of gear for test run A. (a) Gear raw baseband plot. (b) Gear baseband envelope.

Figure 8(a) shows a plot of the gear pair raw baseband and Fig. 8(b) shows a plot of the gear pair base band envelope from the test A with the loose pinion hold down nut which ran a total of 122 hr. These plots were taken near the end of the test. The horizontal scale covers one revolution of the gear and shows the condition of each of the 36 teeth on the gear, while the vertical scale is the amplitude of the signal and indicates the intensity of the tooth load. Figure 8(a) shows an increase and decrease in amplitude at three locations during one revolution of the gear which indicates the eccentric condition of the pinion which is running at three times the speed of the gear. The 36 teeth on the gear can be seen in these plots.

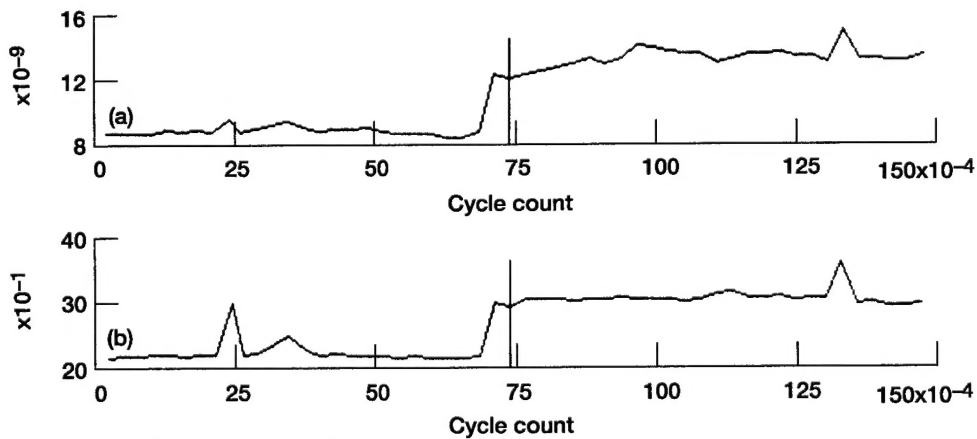
Figure 9.—Features plots of gear for test run A. (a) Total energy gear baseband envelope. (b) Kurtosis of gear baseband envelope.

Figures 9(a) and (b) shows some of the feature plots, produced by the diagnostic system for the test A with the loose nut. These plots show the various parameters from the start until the end of testing and are generated from the data shown in Figs. 8(a) and (b). These plots show the total energy of the gear base band envelope (Fig. 9(a)) and kurtosis of the gear raw baseband (Fig. 9(b)). From these figures it appears that something happened approximately half way through the test, however there were no indications of a failure in the time averaged vibration plots at this time. Near the end of the test these feature plots still indicate that something has happened. The time averaged vibration plots show a three cycle wave giving a change in amplitude with each revolution of the pinion. This condition was caused by a loose pinion nut that allowed the pinion to run in an eccentric condition thereby producing the three cycle amplitude variation per gear revolution.

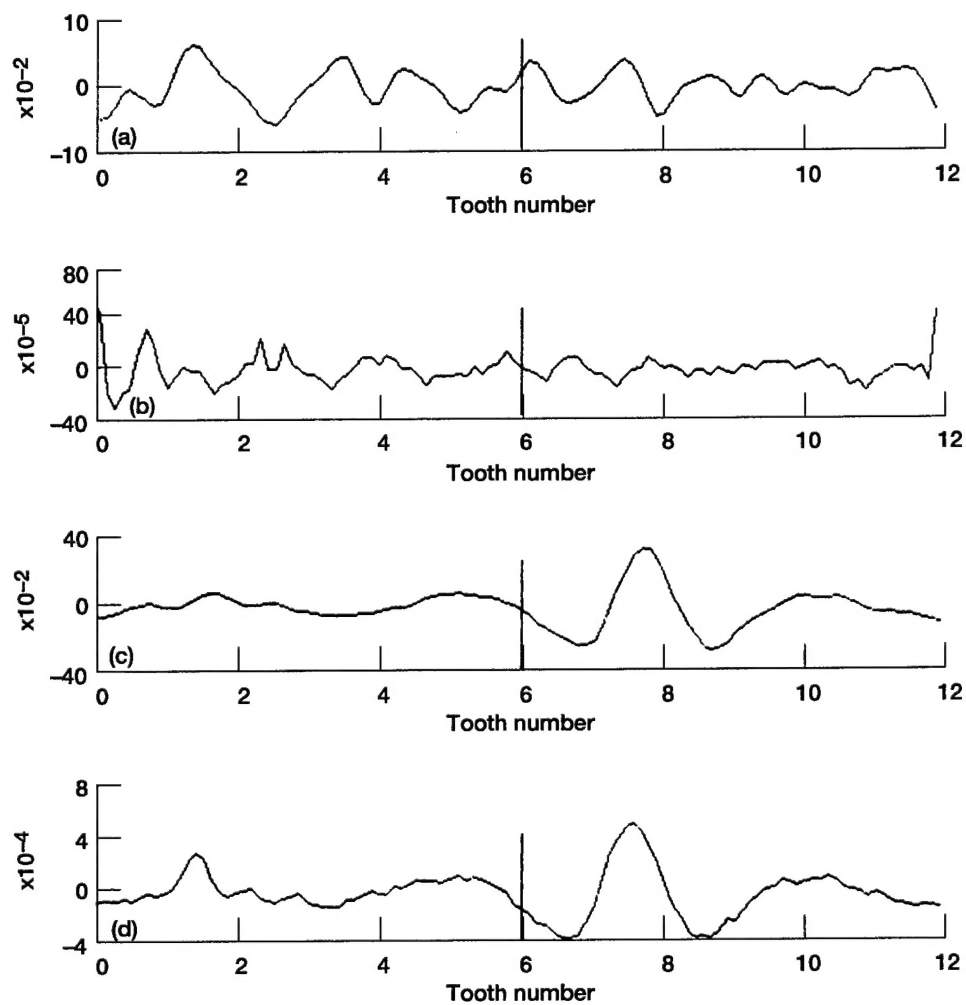
Figure 10.—Time synchronous average plots of pinion for test run B. (a) Pinion stresswave start of test. (b) Pinion baseband envelope start of test. (c) Pinion stresswave end of test. (d) Pinion baseband envelope end of test.

Figures 10(a) to (d) shows the time averaged plots of the pinion stresswave and the pinion base band envelope from test B. Plots 10 a and b were taken at the start of the test and plots 10 c and d were taken at the

end of the test. Near the end of the test the pinion stresswave and pinion baseband envelope show an increased amplitude for one tooth (tooth number 8). This indicates an increased loading for this tooth.

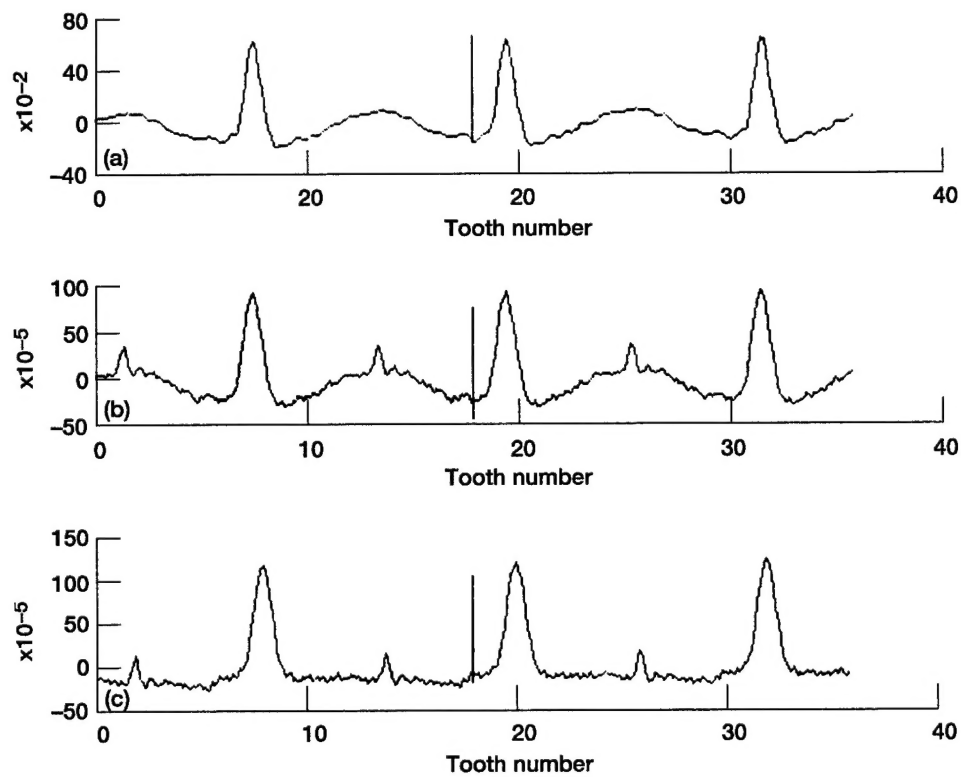
Figure 11.—Time synchronous average plots of gear for test run B. (a) Gear stresswave. (b) Gear baseband envelope. (c) Hunting tooth baseband envelope.

Figures 11 (a) to (c) are the time averaged plots of the gear stresswave, gear baseband envelope, and hunting tooth baseband envelope for test B. Each of these curves shows the gear teeth at locations 8, 20, and 32 to have a very high amplitude compared to the other teeth on the gear. These are exactly 12 teeth apart which is the number of teeth on the pinion. This increased amplitude of the three teeth on the gear is a result of the surface fatigue damage of one tooth on the pinion shown in Fig. 12.

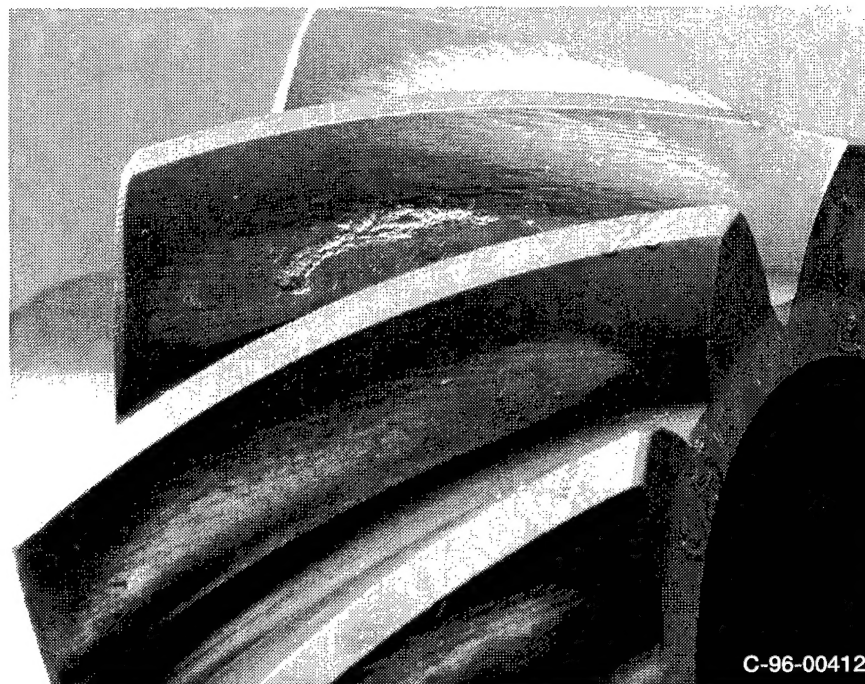
Figure 12.—Pinion tooth fatigue spall test run B.

Figure 13 shows six of the 14 feature plots, for test B. These plots were generated from the data shown in Figs. 10 and 11. Figures 13(a) to (c) are the (a) peak residual ratio, (b) kurtosis and (c) total energy of the pinion stresswave. Figures 13(d) to (f) are (d) the peak residual and (e) total energy of the gear baseband envelope and (f) the kurtosis of the gear stresswave. From these figures it is clear that not much damage occurred until the last 15 percent of total test time. After about 85 percent of total test time all of the above indicators began a steady and continuing increase in amplitude until the test was stopped. The pinion time averaged plots, Figs. 10(c) and (d) show that one tooth (tooth number 8) on the pinion was producing a higher dynamic load than the other teeth. This tooth was found to have fairly sizable fatigue spall as shown in Fig. 12.

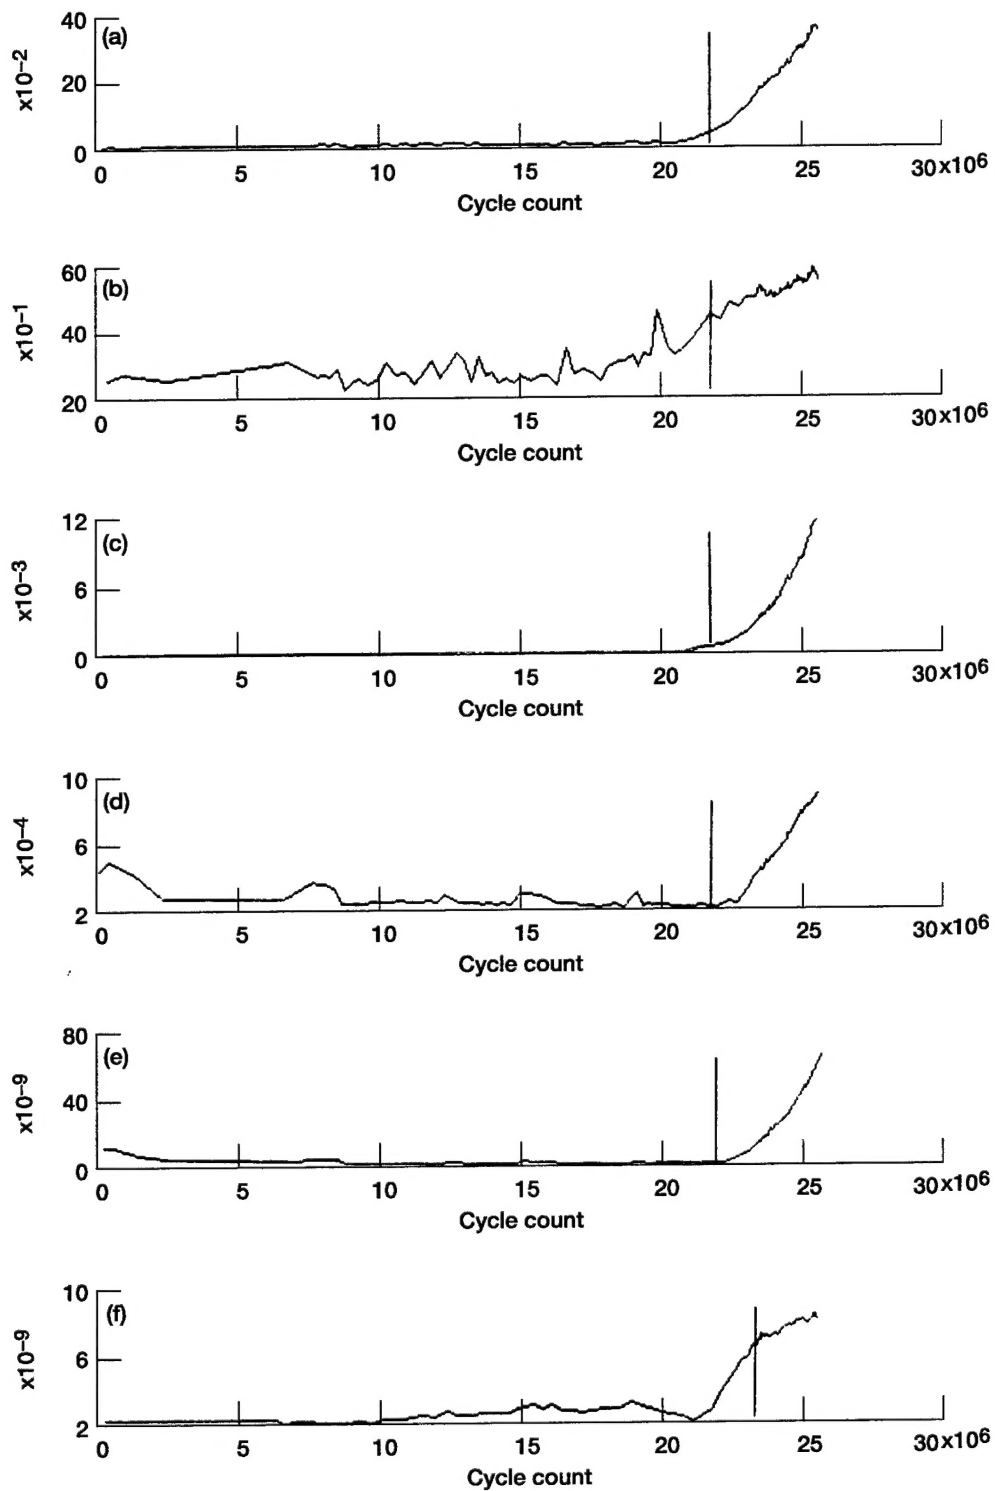
Figure 13.—Features plots for test run B. (a) Peak residual pinion stresswave. (b) Kurtosis pinion stresswave. (c) Total energy pinion stresswave. (d) Peak residual gear baseband envelope. (e) Total energy gear baseband envelope. (f) Kurtosis gear stresswave.

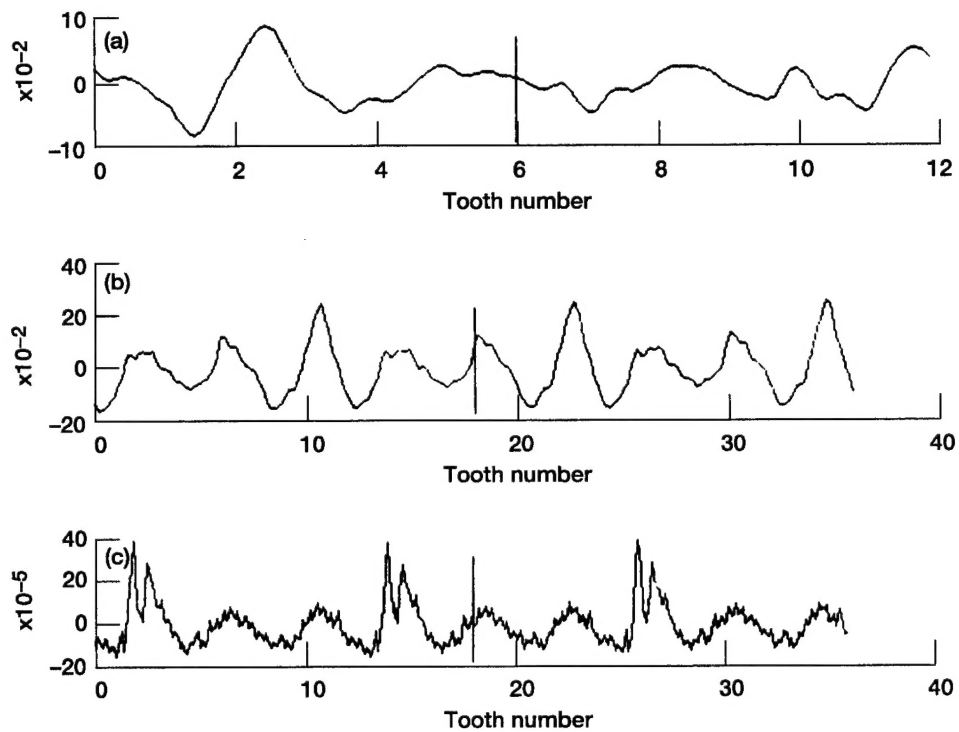
Figure 14.—Time synchronous average plots of test run C. (a) Pinion stresswave. (b) Gear stresswave. (c) Hunting tooth baseband envelope.

Another gear test run C completed a total of 527 hr and had some fatigue damage on one tooth. The plots for the time averaged pinion stresswave, gear stresswave and hunting tooth baseband envelope are shown in Figs. 14(a) to (c) respectively. A signal from each individual tooth cannot be seen on these figures, however these figures show an increase in amplitude for one area of the pinion near tooth number 3 and for three areas of the gear. This indicates that one location on the pinion is contributing to an increase in dynamic load. Figure 15 shows the fatigue spalls on the pinion and gear for test C.

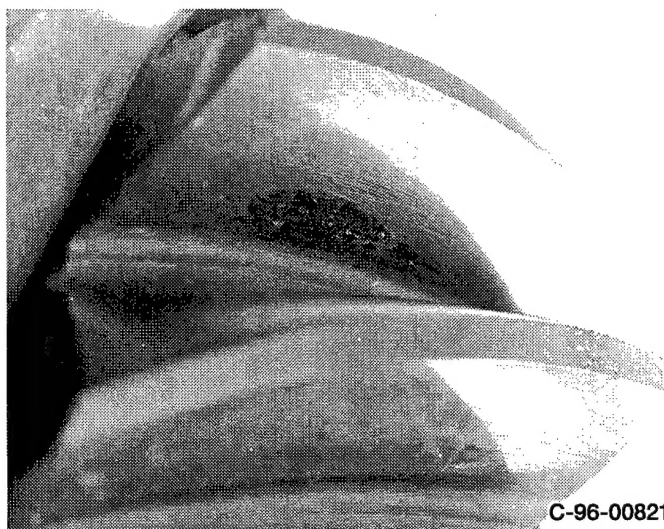
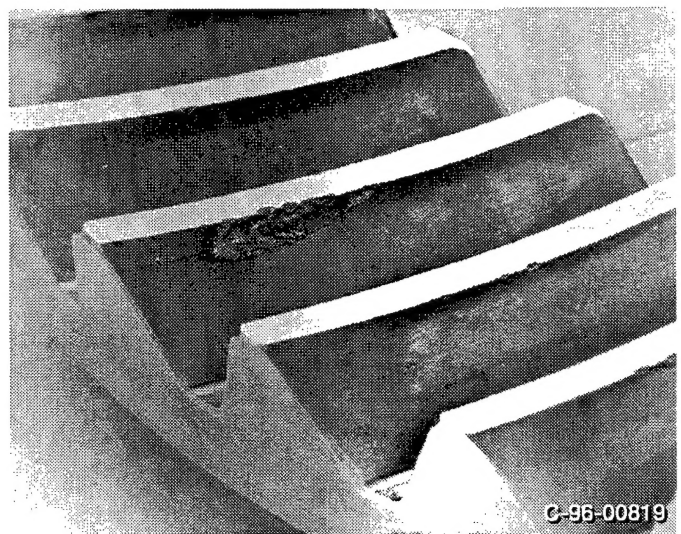
Figure 15.—Gear and pinion fatigue spall for test run C.

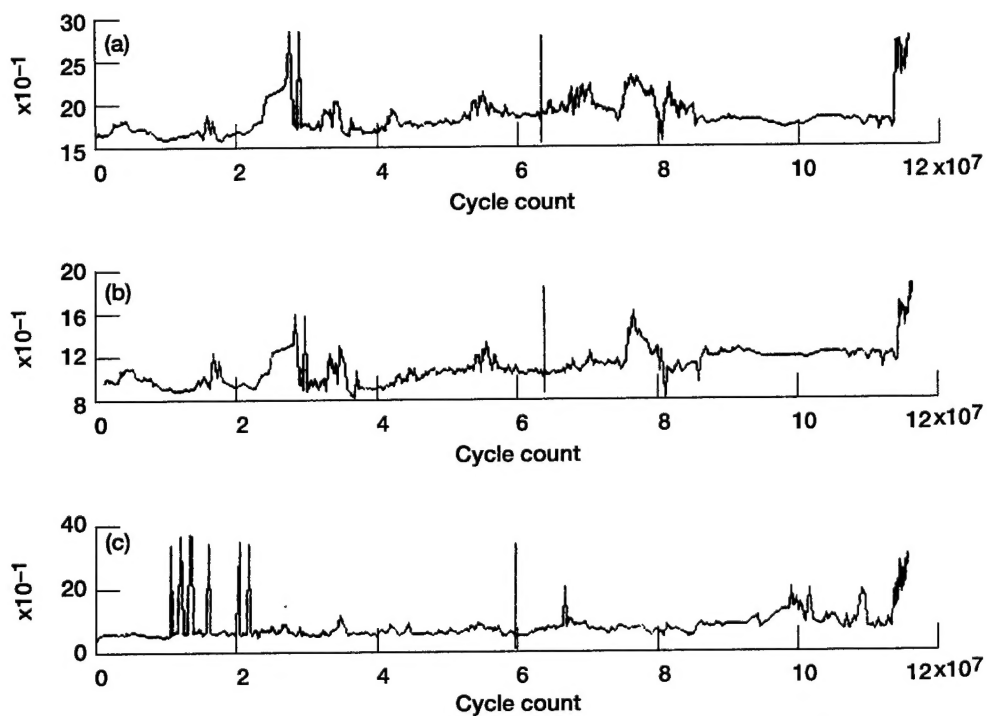
Figure 16.—Features plots of test run C. (a) Kurtosis gear stresswave. (b) Peak ratio gear stresswave. (c) Peak residual ratio baseband envelope.

Figures 16(a) to (c) are the feature plots for test C and show the kurtosis and peak ratio for the gear stresswave and the peak residual ratio for the gear base band envelope. These plots show an increase in these parameters near the end of the test C and are an indication of increased vibration activity caused by the pinion fatigue spall. The earlier peaks were probably the result of stopping and starting the test.
